# 2025 Jeep Wrangler 4xe: Sudden Loss of Drive Power

*What owners are reporting, what it appears to be, what the dealer and manufacturer say — and how to report it.*

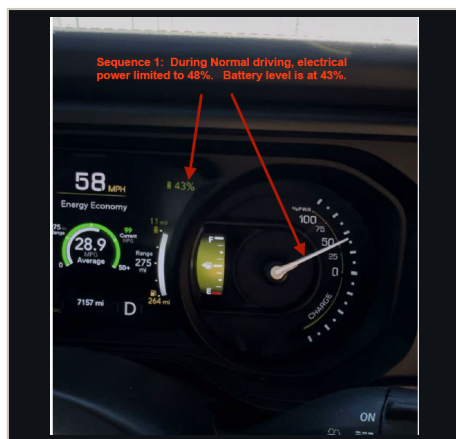
1 — power limited to ~48% (battery 43%, 58 mph)

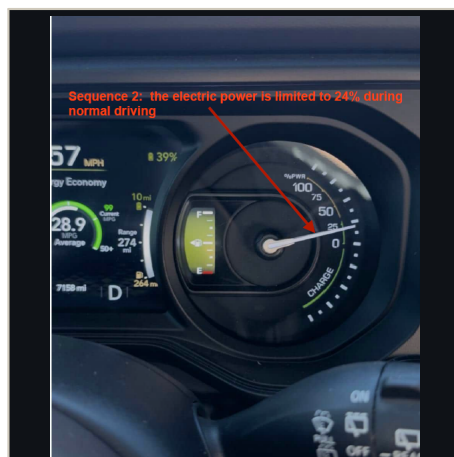
2 — reduced to ~24% (battery 39%, 57 mph)

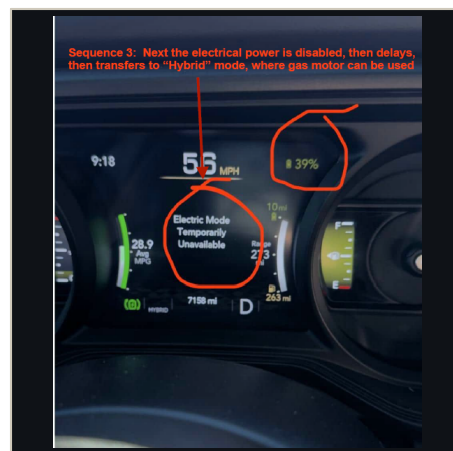
3 — "Electric Mode Temporarily Unavailable" → hybrid
